Methods for determining groundwater under the influence of surface water, and BMPs for mitigating distribution system contamination

Summary

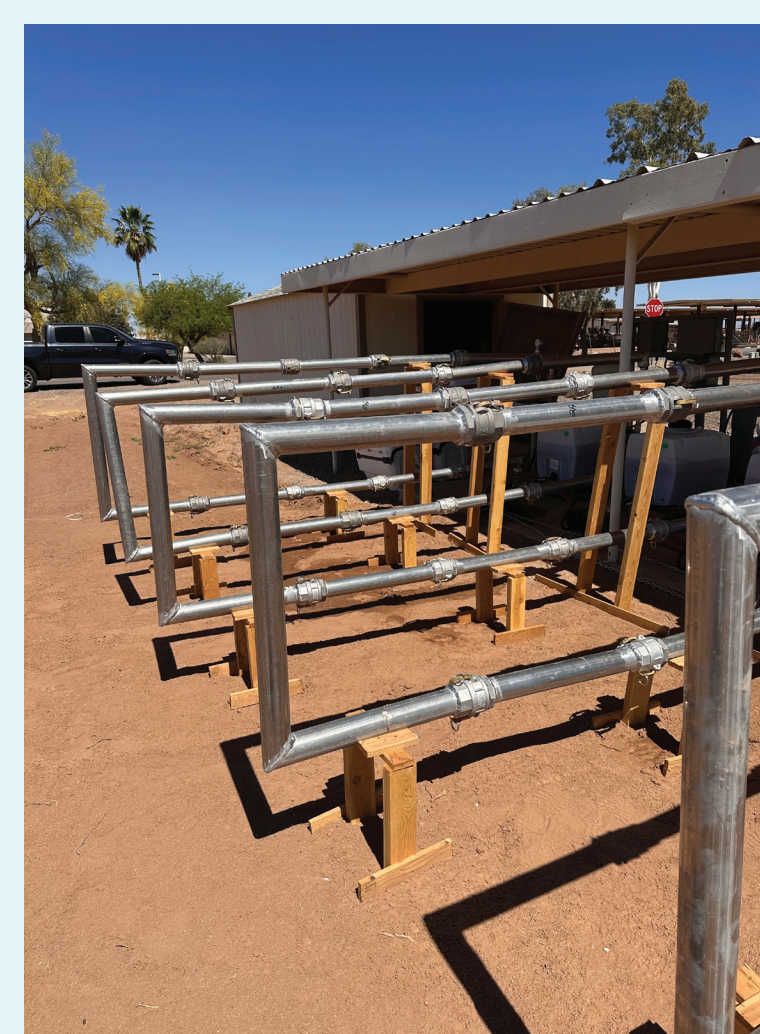
Figure 1:
Aluminum Irrigation Pipe Loop

The project team has completed well assessments and had initiated work to evaluate irrigation water distribution system impacts resulting from the use of organic fertilizers and “mock” microbial contamination. Results indicate rapid microbial growth within short periods of time (< 7 days) and orders of magnitude increases in microbial concentration in both the circulated water as well as biofilm swabs, ranging from ~1.8 to 2 log/100ml to ~7.6 to 7.7 log /100ml in irrigation water, and from ~1.2 log/swab to >8 log/swab on pipe. These results were similar in varying pipe materials including both aluminum and PVC pipe. Of note, microbial concentrations remained elevated after subsequent “clean” irrigation water introductions regardless of any new microbial introduction indicating that once irrigation pipe(s) becomes contaminated, in the presence of organic fertilizer, bacteria may persist at extended periods of time with no interventions in place.

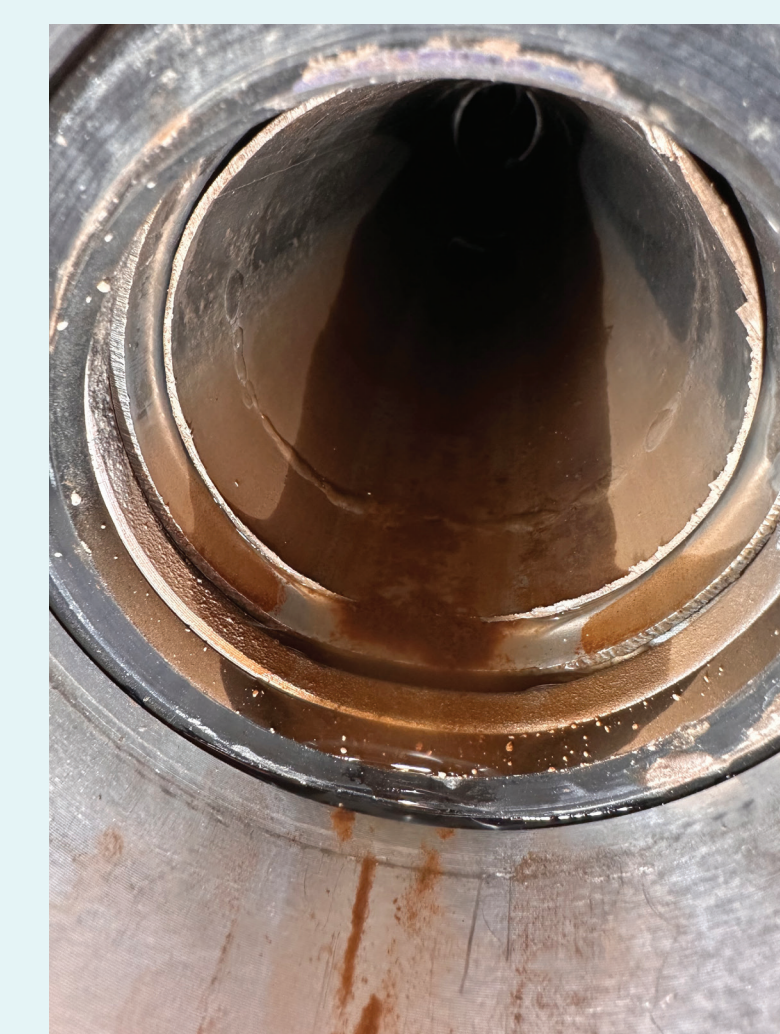
Figure 2:
Cross sections of aluminum pipe used for mock irrigation of fresh produce with surface water over 28 days showing substantial biofilm development.

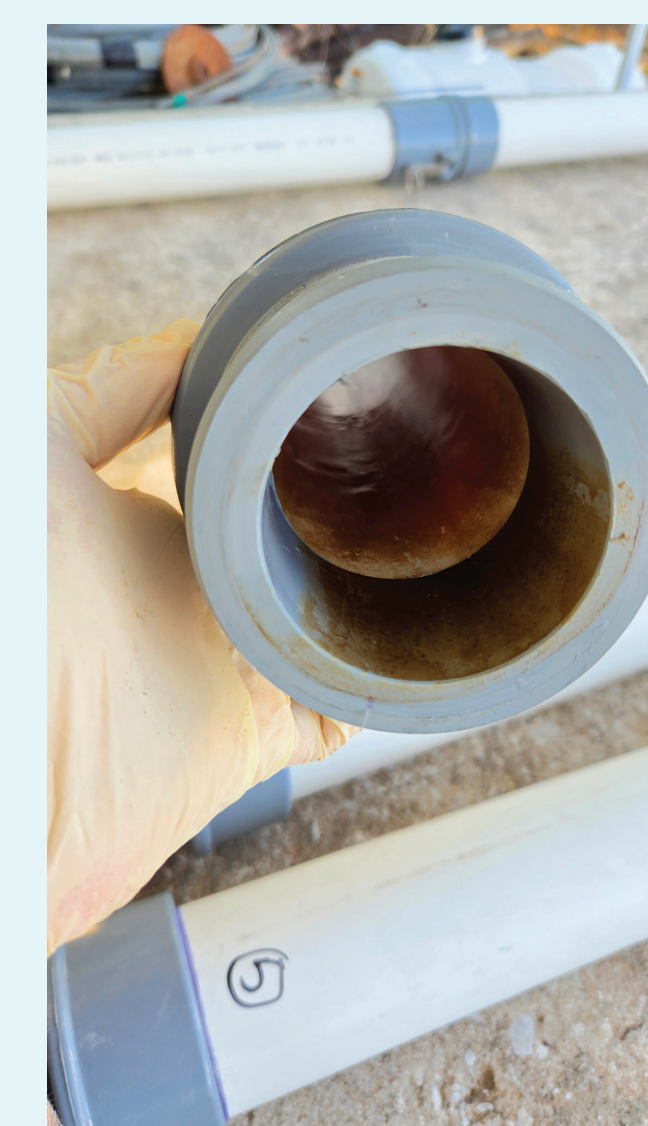
Figure 3:
Cross sections of PVC pipe used for mock irrigation of fresh produce with surface water over 28 days showing substantial biofilm development.
